Applies To: **1999 3.2TL** – ALL
2000 3.2TL – From VIN 19UUA5...YA000001 Thru VIN 19UUA5...YA008807

April 24, 2000

Squeak or Creak From the Driver's Seat

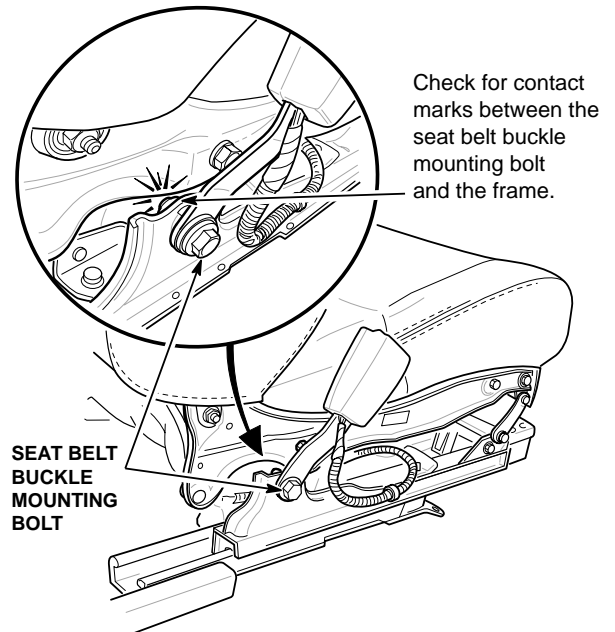
1. Lower the driver's seat to its lowest position, and then remove it. Refer to page 20-74 in the 1999-00 3.2TL Service Manual.
2. Remove the right side cover from the seat cushion, and check for contact marks between the seat belt buckle mounting bolt and the seat frame.
 - If there are contact marks, go to step 3.
 - If there are no contact marks, go to step 4.

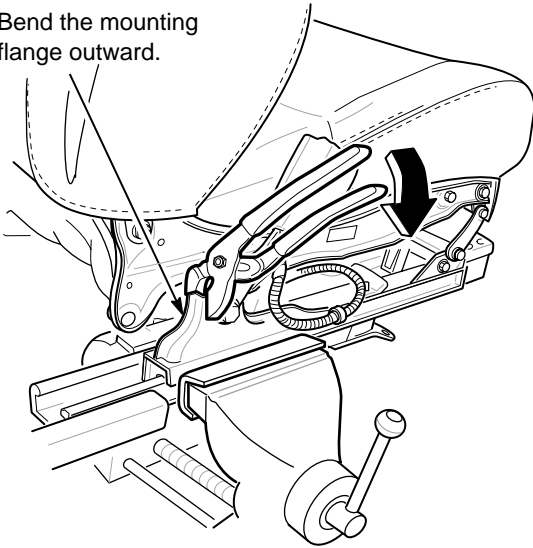
The seat cushion is rubbing against the seat frame, and/or the seat belt buckle mounting bolt is rubbing against the seat frame.

3. With an assistant supporting the seat, clamp the seat rail in a vise, and bend the seat belt buckle mounting flange away from the seat frame with a pair of pliers.

Bend the mounting flange outward.
