YEAR  
1989 - 90

MODEL  
LEGEND

BULLETIN NO.  
93-019

## Product Update: Legend Igniter

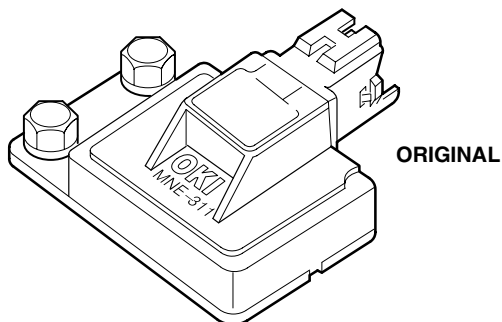
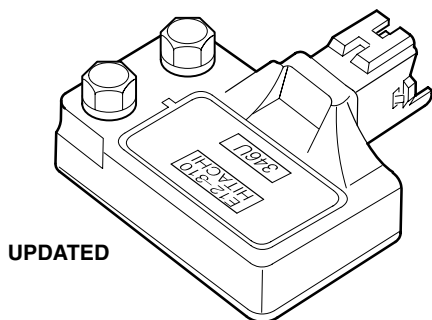
1. Inspect the igniter mounted on the left inner fender panel.
  - If the mounting bolts go through the heat sink, it is not an updated igniter. Continue with this replacement procedure.
  - If the mounting bolts go through the igniter body, it is an updated igniter. Go to step 6.

Replace the igniter with the updated part listed under PARTS INFORMATION.
