Safety Recall: Right Front Impact Sensor Is Loose

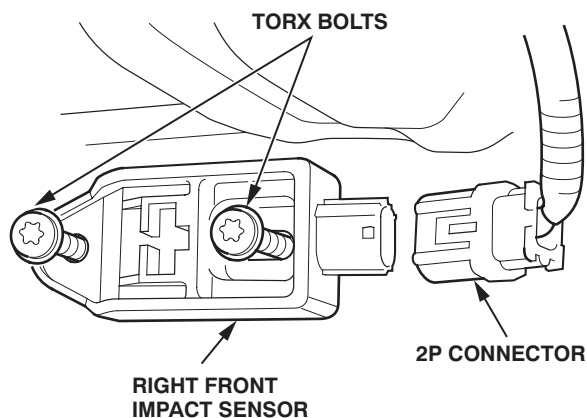
On some 2006 TLs, the bolts on the right (passenger's side) front impact sensor were not properly torqued. If the bolts loosen or fall out, the sensor may fail to properly detect a crash, possibly resulting in delayed or non-deployment of the passenger's airbag.

1. To keep the front airbags from deploying, turn the ignition switch off, remove the key, and wait at least 3 minutes.
2. Remove the front bumper. Refer to page 20-124 of the 2004–06 TL Service Manual.
3. Disconnect the 2P connector from the right (passenger's side) front impact sensor.

4. Using a Torx T30 bit, loosen the sensor's two Torx bolts to see if they are cross-threaded.
5. Hold the sensor tight against its bracket while you torque the Torx bolts to 9.8 N·m (7.2 lb-ft).
6. Reconnect the sensor's 2P connector.
7. Reinstall the front bumper.
8. Turn the ignition switch to ON (II), and watch the SRS indicator.
 - If the indicator comes on for about 6 seconds and then goes off, go to step 9.
 - If the indicator comes on but doesn't go off, troubleshoot the SRS for other possible problems, then go to step 9.
