YEAR
1992

MODEL
VIGOR

BULLETIN NO.
92-006

Blower Motor Unit Only Runs on High or Whistles

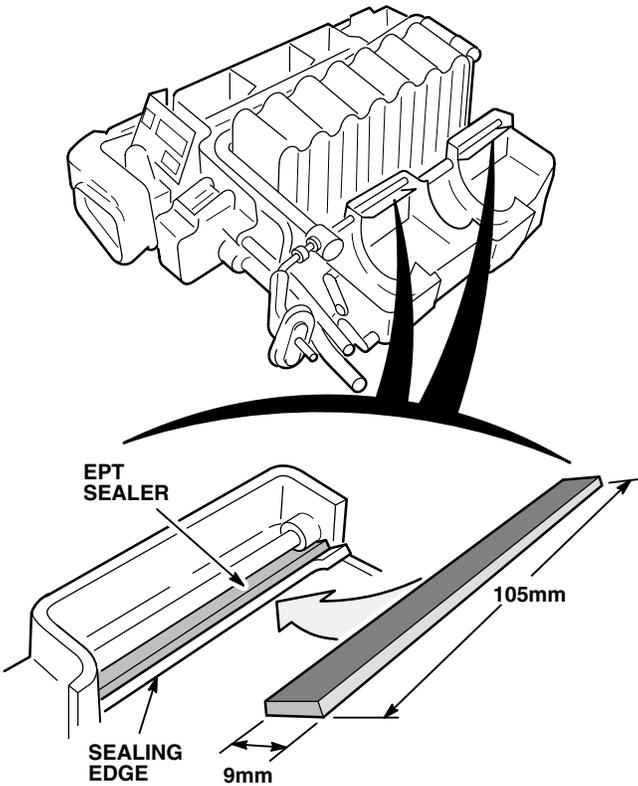
A molding deformity in the heater unit cases around the recirculation door area allows air to enter between the case halves. This causes a whistling noise through the vents.

8. Remove and replace the blower motor following the procedure on page 22-53 of the service manual. Be sure to install the washers on the blower motor shaft first, then install the fans.
9. Replace the power transistor, only if the customer complaint was that the blower motor only runs on high.
10. Inspect the areas shown for EPT sealer. If there is no EPT, apply a 105 x 9 mm strip of EPT sealer 5T to each area. Be sure the EPT is even with the inner sealing edge.
