MODEL
3.5RL
3.2TL

BULLETIN NO.
99-038

Safety Recall: Extension Shaft Sealing Bolt

(Supersedes 99-038, dated August 19, 1999)

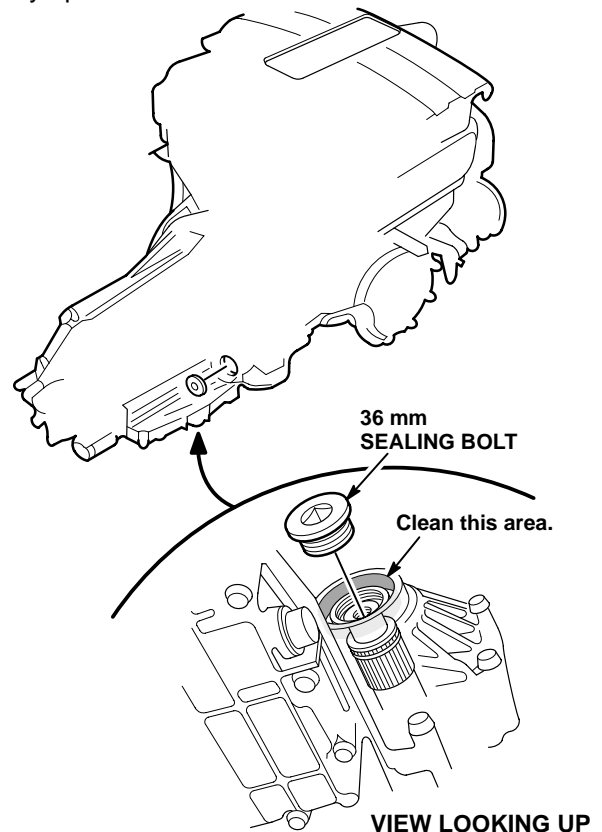
The 36 mm sealing bolt on the side of the transmission housing may loosen and fall out. If this occurs, the extension shaft may back out and disconnect from the differential. If this happens while driving, the car loses power to the drive wheels without warning. If the car is stopped with the transmission in Park and the parking brake not engaged, the car could move unexpectedly.

1. Make sure the vehicle is in Park, then raise the vehicle on a hoist.
2. Use brake cleaner and compressed air to clean the area around the 36 mm sealing bolt. Wear eye protection.

3. Remove the 36 mm sealing bolt.
4. Use brake cleaner and compressed air to clean the threads in the transmission housing. Wear eye protection.
5. Install the O-ring on the new sealing bolt.
6. Install the new 36 mm sealing bolt. Do not use any thread lock or thread sealer. Torque the bolt to 78 N·m (58 lb-ft).
7. Lower the vehicle.
8. Center-punch a completion mark above the fifth character (A) of the engine compartment VIN.
